A33N Endurance Testing

Rev. 1.2.1

Cobra Aero, LLC
240 Uran Street
Hillsdale, MI 49242
517-437-9100

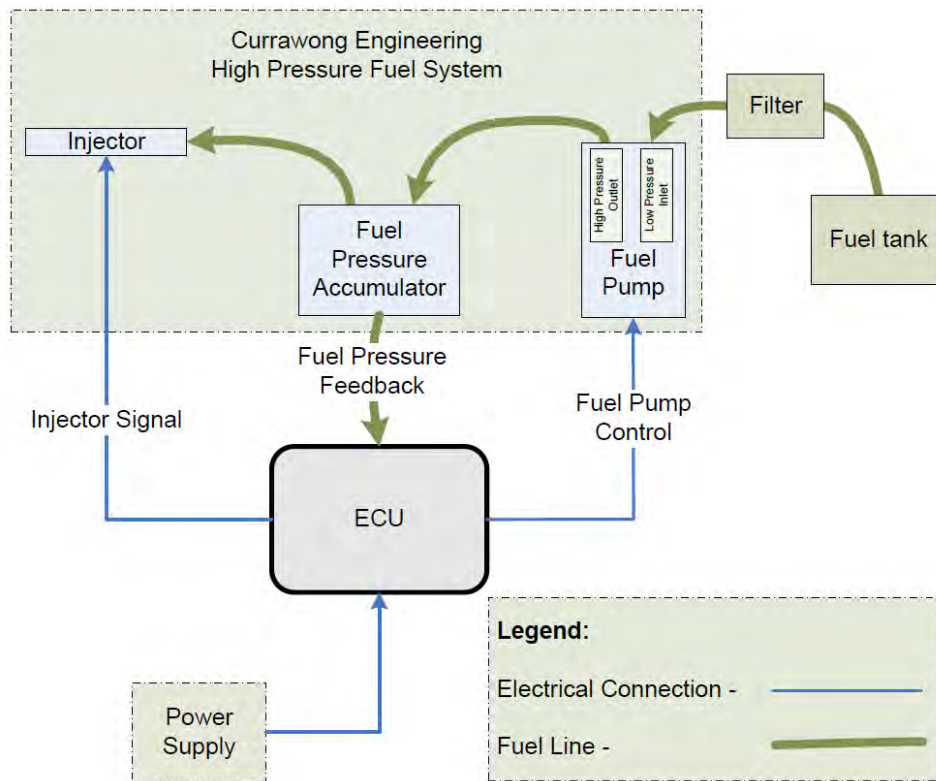
Figure 3: Fuel system schematic (vent line not shown)

Engine fuel was unleaded 98 Octane Sunoco 260GTX premixed with Ultra Blue 2-stroke aviation oil at a 50:1 ratio. Fuel was fed into a 10-micron fuel filter which in turn was fed to the fuel pump attached to the ECU. The fuel pump, which duty-cycles based on pressure feedback from the ECU, fed to the injector on the engine in a dead-head configuration. Just before the injector, a T-fitting was added to provide a vent line back into the fuel tank for purposes of relieving pressure and priming air out of the fuel lines. See Figure 3.

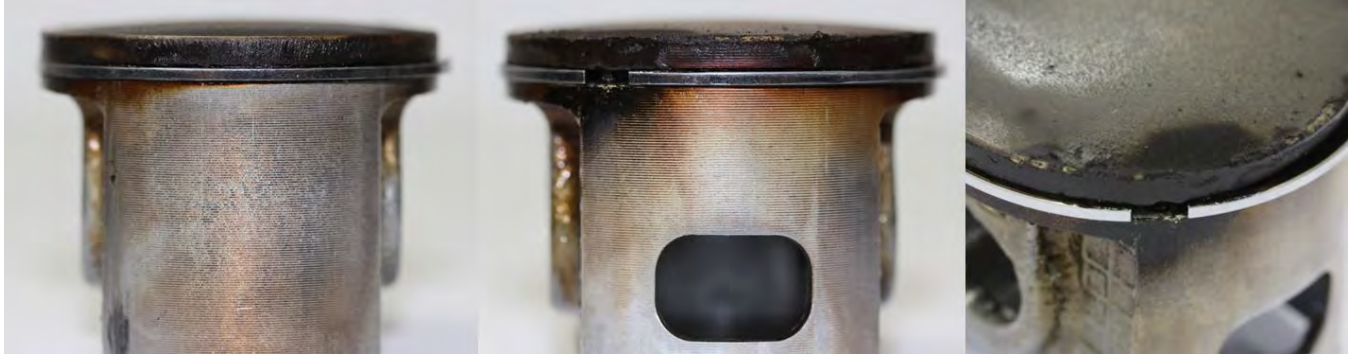
- The top-end, muffler and reeds were disassembled and inspected.
- The piston was found to be in very good overall condition. Note that the top-end had approximately 30 hours on it prior to the start of this test. Machining marks are still clearly visible on both the front and back (thrust) sides of the piston.

Some top ring land coking is visible near the ring gap, however, the piston ring was still free as it appears that the semi-keystone ring shape was effective in shedding excess carbon buildup. The ring gap was set at 0.004” when it was installed, and at the end of the test it measured 0.006”.

Figure 9: Piston views (150.4 hours + previous ~30 hours)

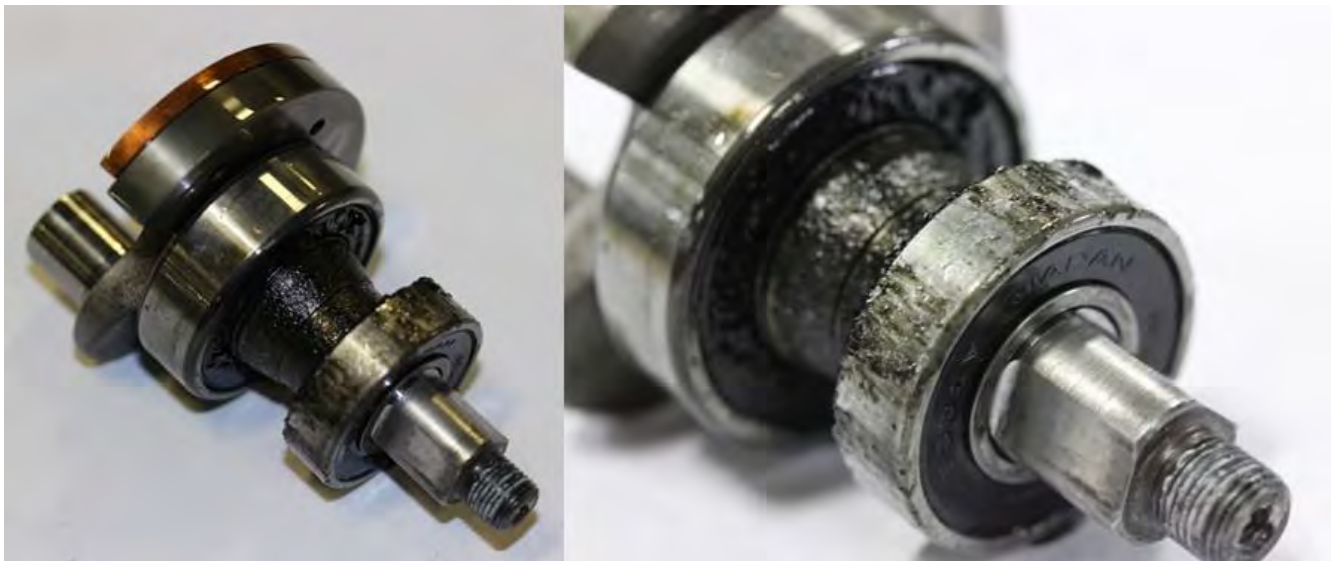
- The crankshaft assembly was in good condition after the test. We did witness some leakage of grease from the sealed bearings, but the bearings felt smooth and tight. The ‘tri-spline’ (where the prop hub rides) was in good condition as well (Figure 10).

Figure 10: Crankshaft Assembly.

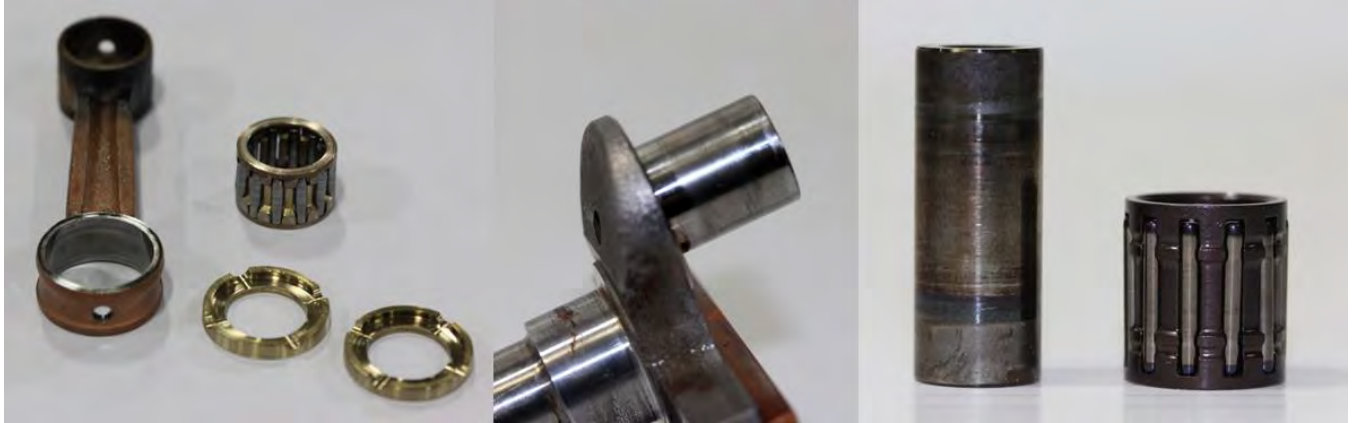
- The top and bottom-end rod bearings finished the test with no issues. (Figure 11).

Figure 11: Top and bottom-end rod bearings with rod guides and crankshaft. All components finished the test with no sign of excessive wear. (150.4 hours)

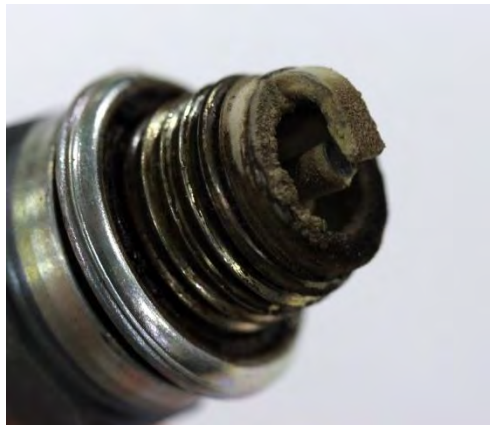
- The spark plug shows signs of coking. The plug gap start: 0.018", end: 0.024".

Figure 14: Spark Plug (150.4 hours)

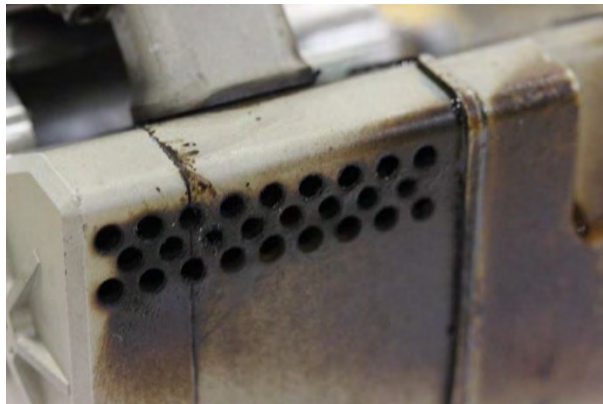
- The exhaust outlet shows small amounts of carbon buildup on the outlet holes.

Figure 15: Exhaust outlet (150.4 hours)

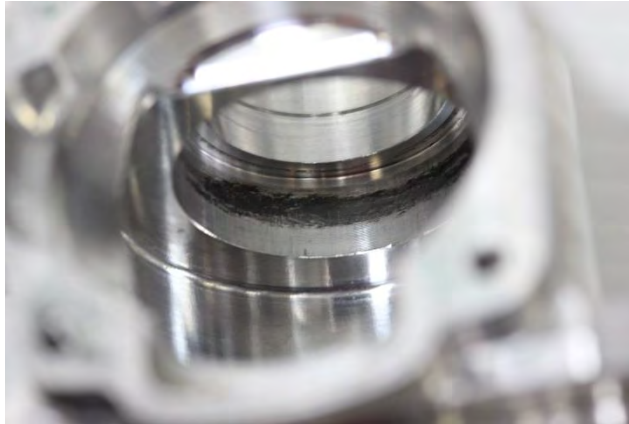
- The main bearing bore in the cases shows some signs of fretting on the bottom side (power stroke). The bearing fit into the case was still tight during teardown.

Figure 16. Main bearing bore (150.4 hours)

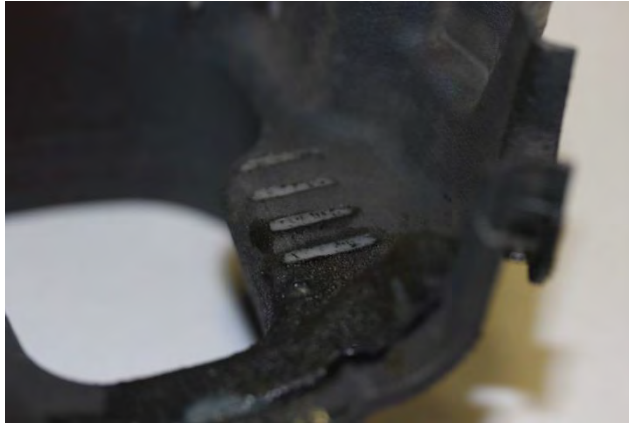
- The cowl shows signs of fretting where the cylinder fins come in contact with the inner surface. The cowl is material is Nylon 12.

Figure 17. Cowl (outlet side).

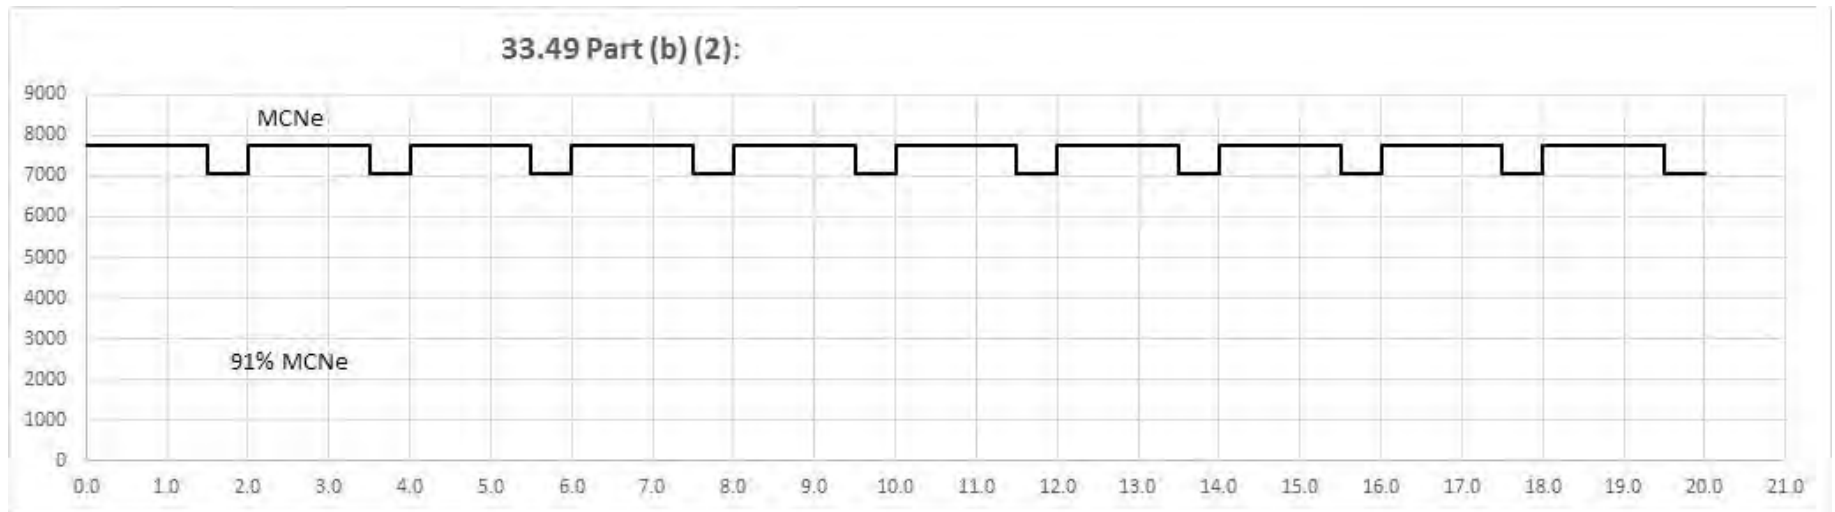
Figure 19: 33.49 (b) (2) - 20 hours

Runs 2 – 6: 20 hour runs each consisting of alternate periods of 1-1/2 hours at rated maximum power with maximum continuous speed and ½ hour at 91% maximum continuous speed (Run 2); 89% maximum continuous speed (Run 3); 87% maximum

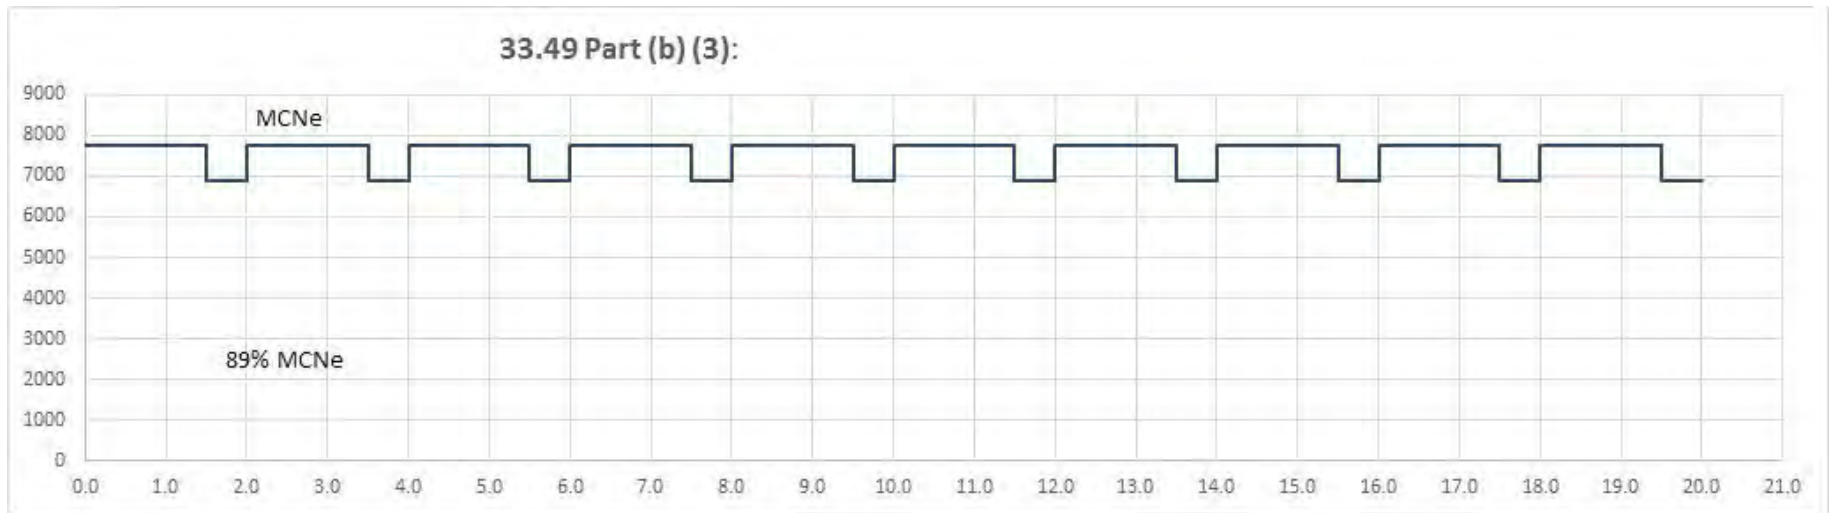
Figure 20: 33.49 (b) (3) - 20 hours

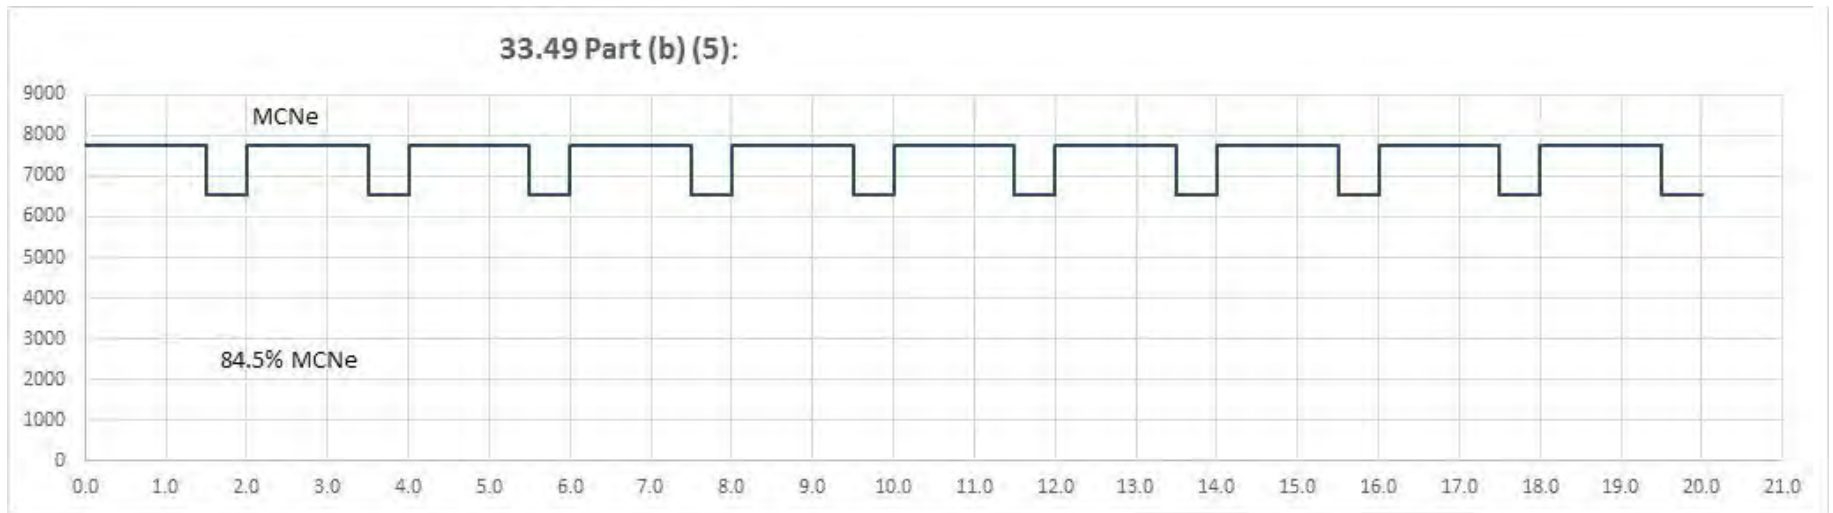
Figure 22:33.49 (b) (5) - 20 hours
